# Environmental Projects: Volume 4

## Asbestos Survey

Goldstone Deep Space Communications Complex

Jet Propulsion Laboratory  
California Institute of Technology  
Pasadena, California

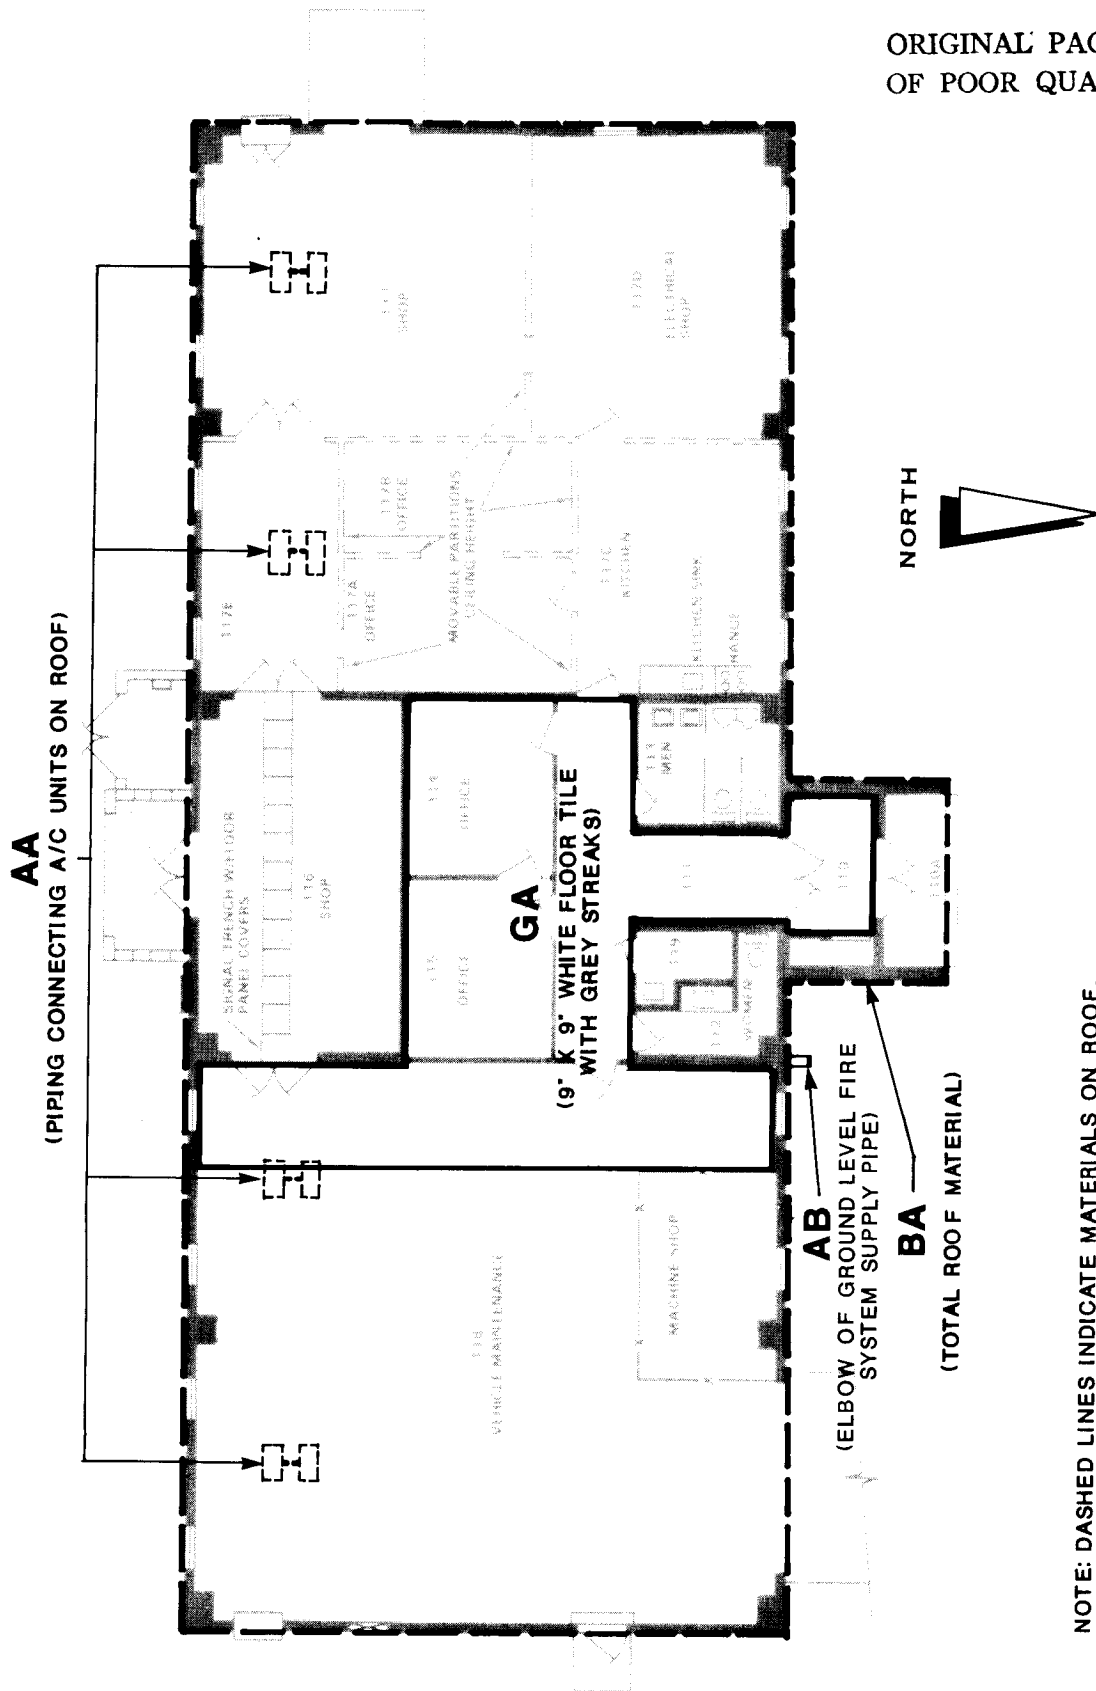
Comments: 9 X 9 in. WHITE TILE WITH GRAY STREAKS. SEE FIGURE 87

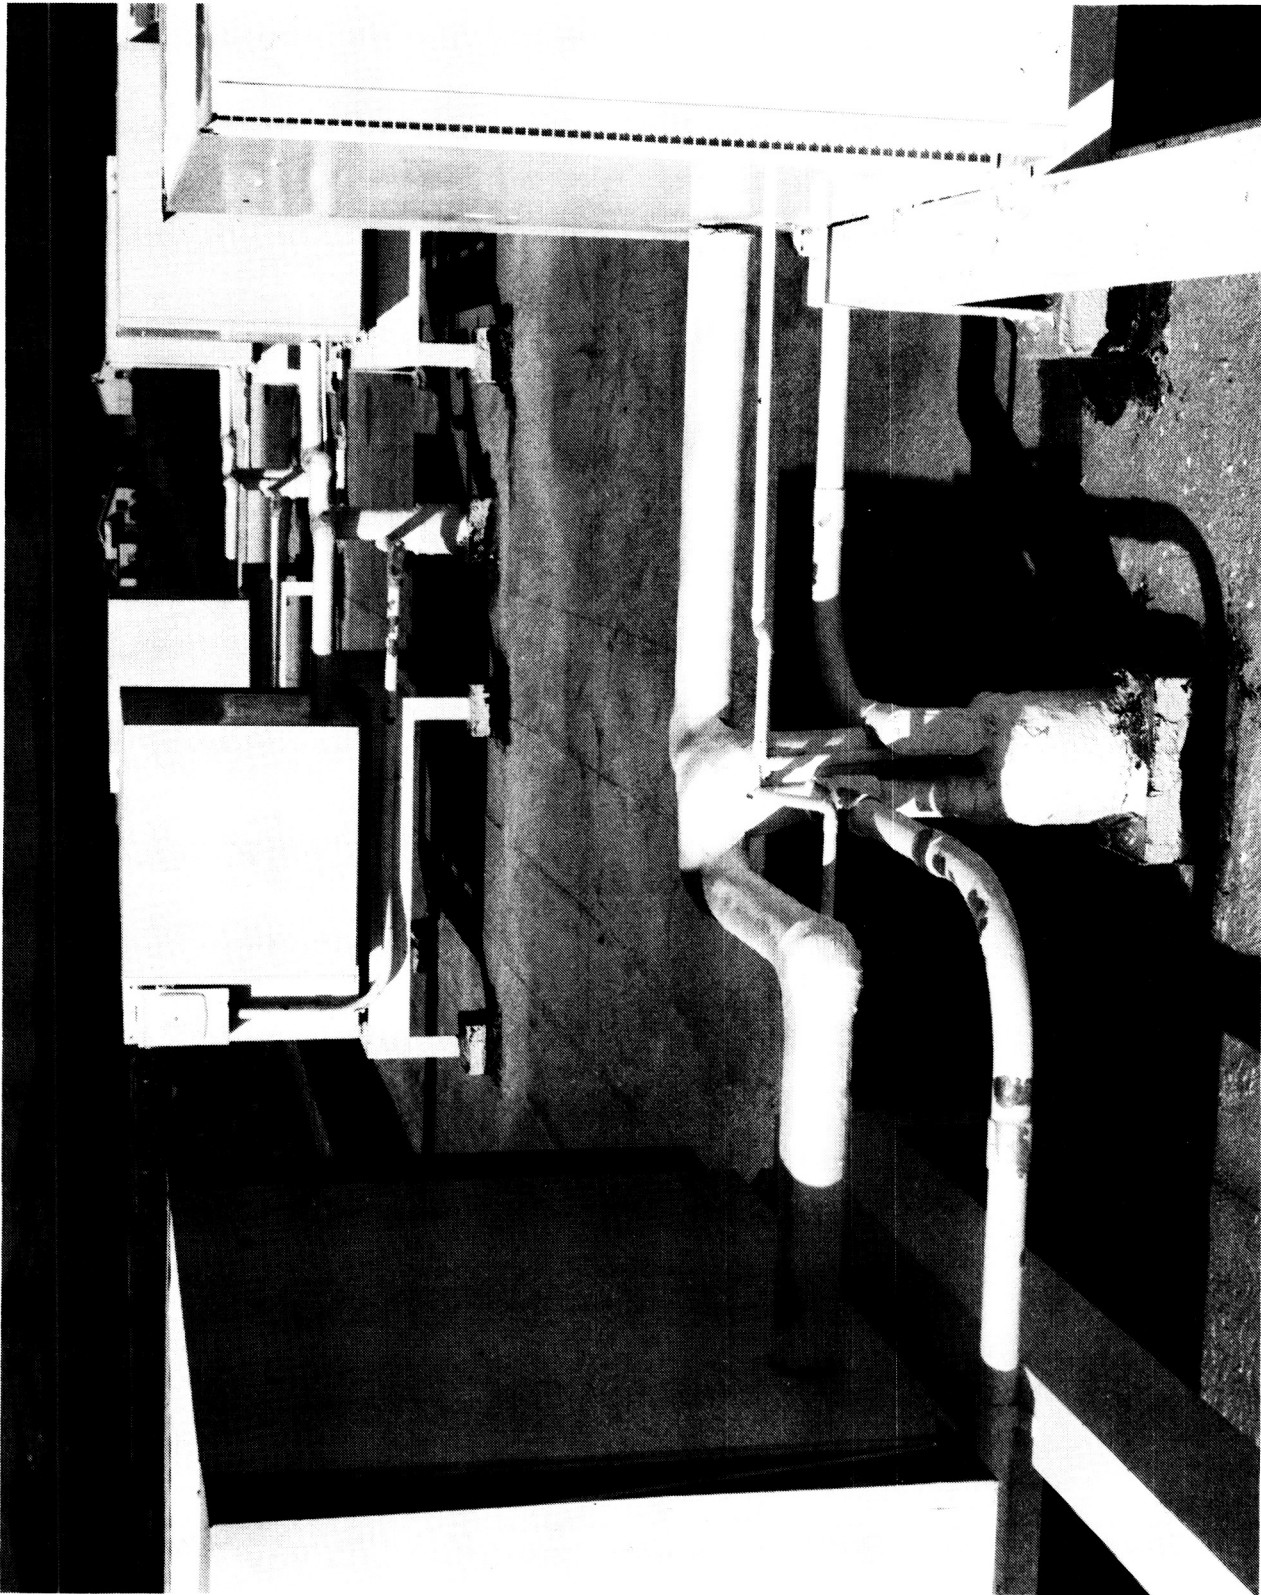
Figure 88. Mojave Base Site: Building M-6, Roof-Mounted Equipment with  
Asbestos-Containing Pipe Lagging.

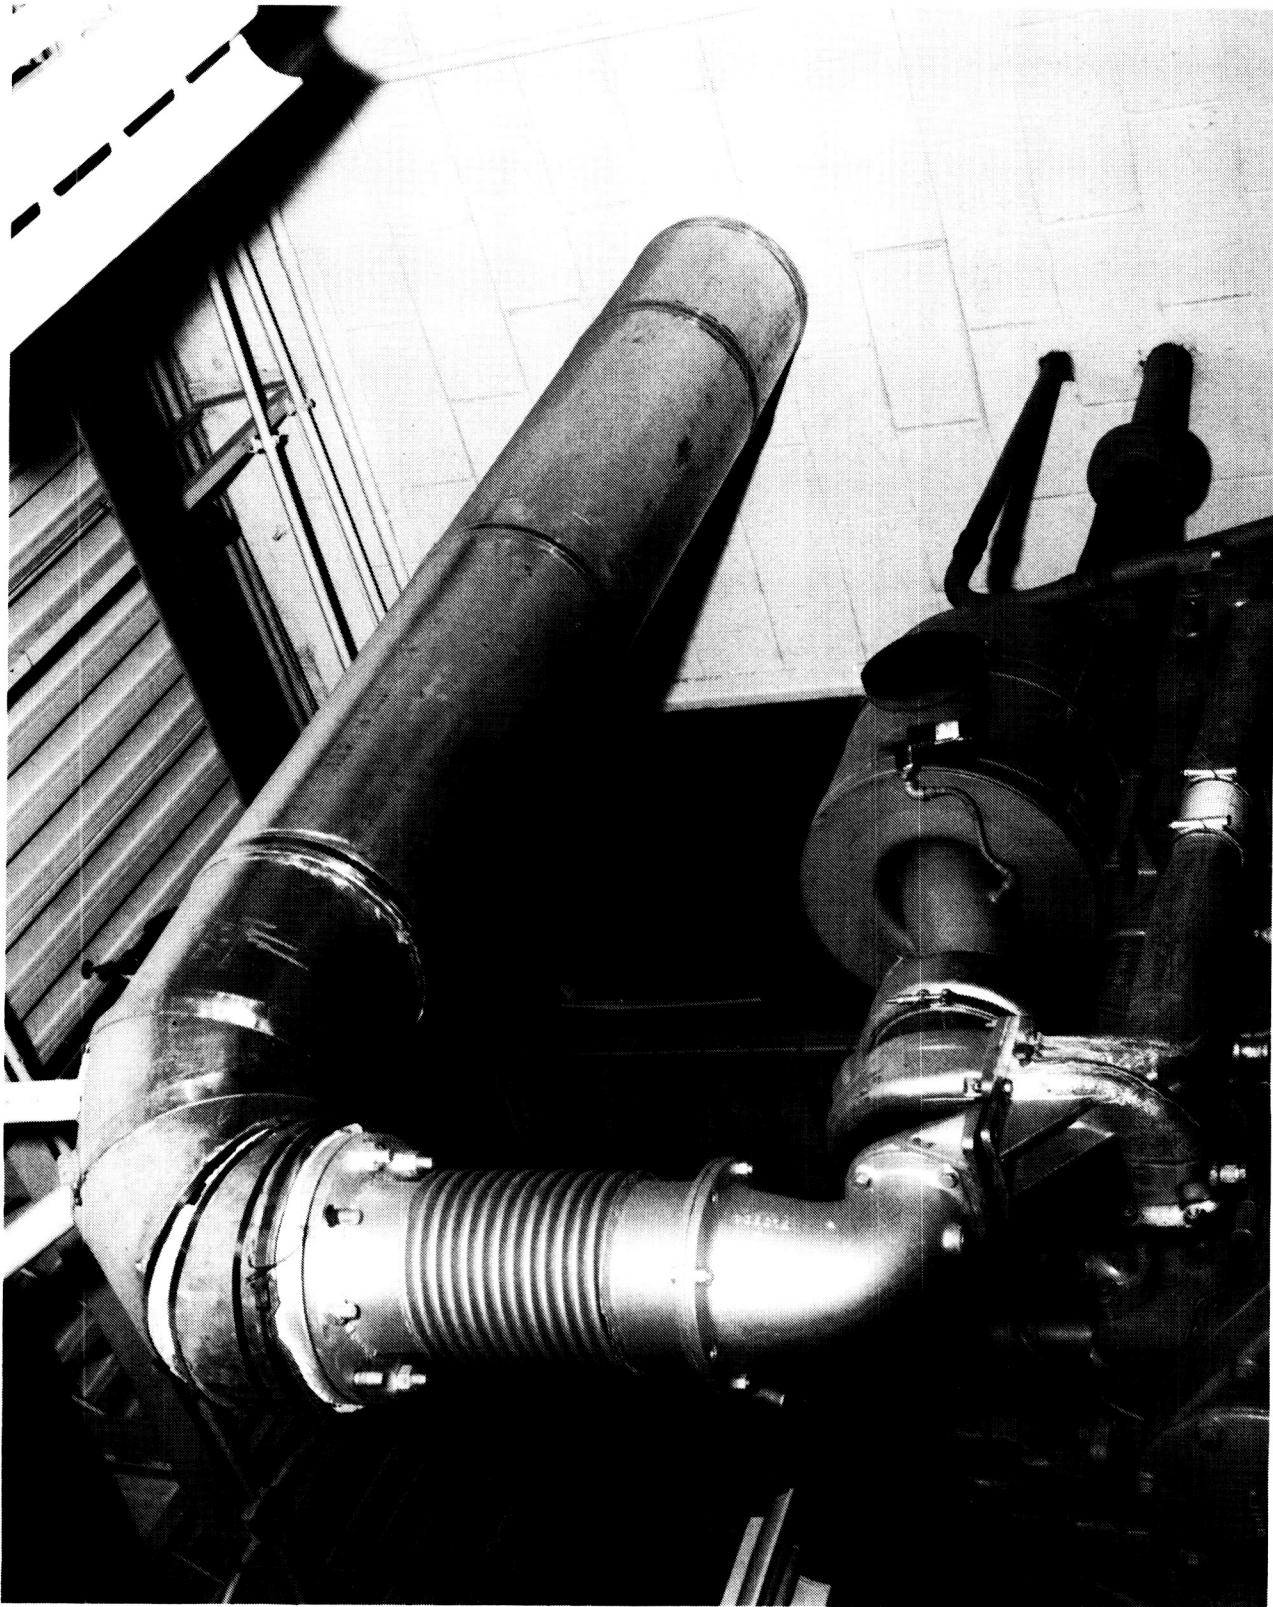
Figure 91. Mojave Base Site: Building M-9, Engine Generator and Gas Turbine Generator Room 108, Typical Asbestos-Containing Lagging for Engine Exhaust Piping.

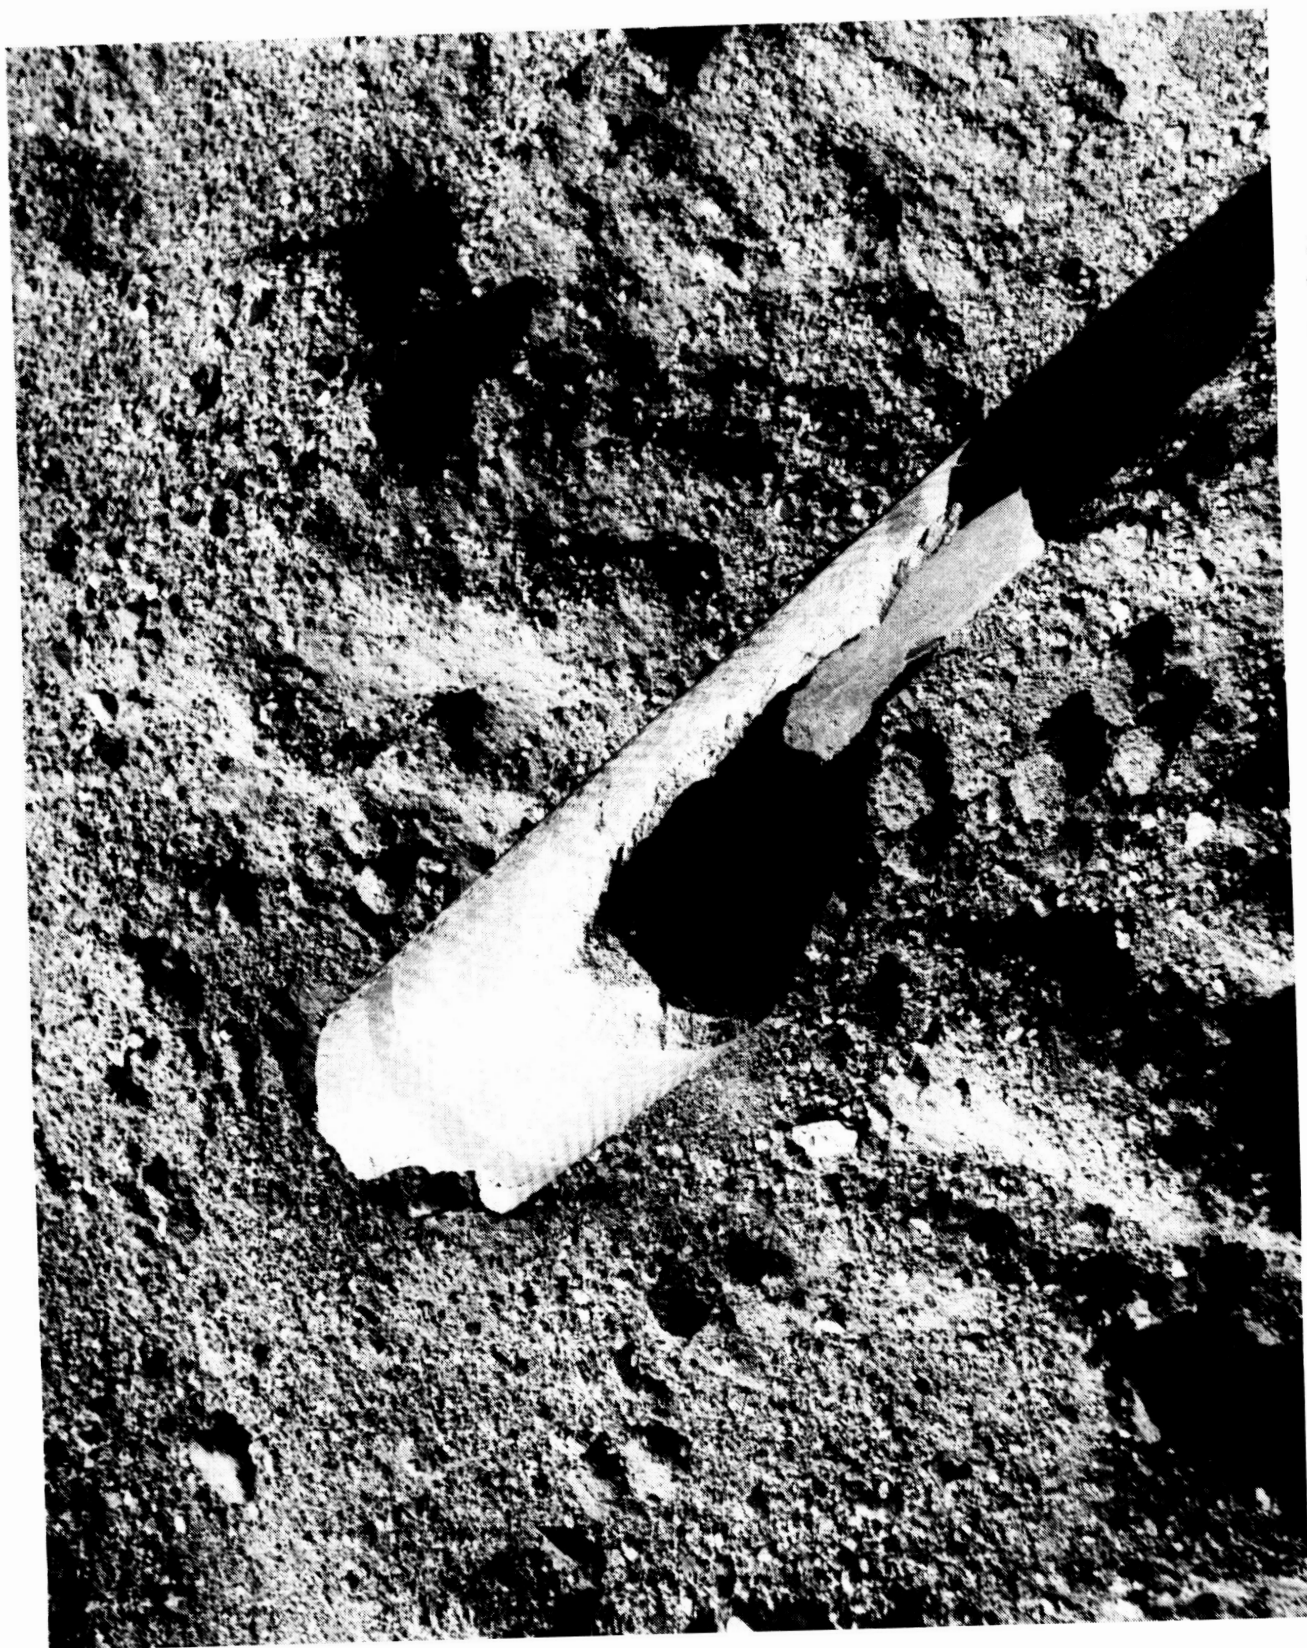
Figure 92. Typical Asbestos-Containing, Underground Electrical Conduit (Unearthed and Broken).
